# Appendix

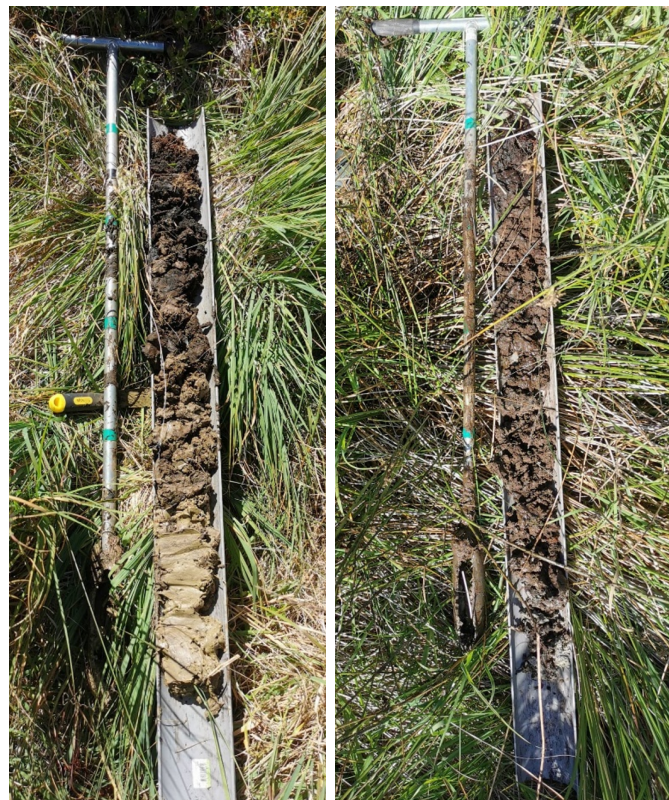
(a) Soil profile 2

(b) Soil profile 6

Figure 44: Soil profiling realized on the southern and central plateau of the study site on August 3<sup>rd</sup> 2022
