École polytechnique de Louvain

Characterization of the behavior of advanced surface treatments to rain erosion: towards a material performance index

Author: **Matthieu VAN DE WYNGAERT**
Supervisors: **Thomas PARDOEN, Pierre BOLLEN**
Readers: **Evelyne VAN RUYMBEKE, Laurent DELANNAY**
Academic year 2020–2021
Master [120] in Chemical and Materials Engineering

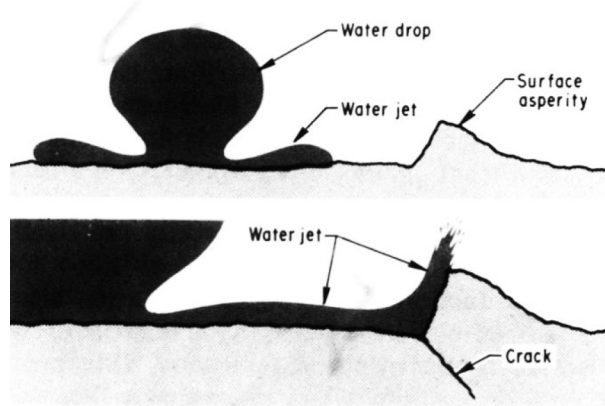
Figure 3: Due to the lateral jetting happening after the impact, the surface irregularities or asperities can be sheared out or cracks can initiate and propagate at their base. Image from Heymann et al. [17]

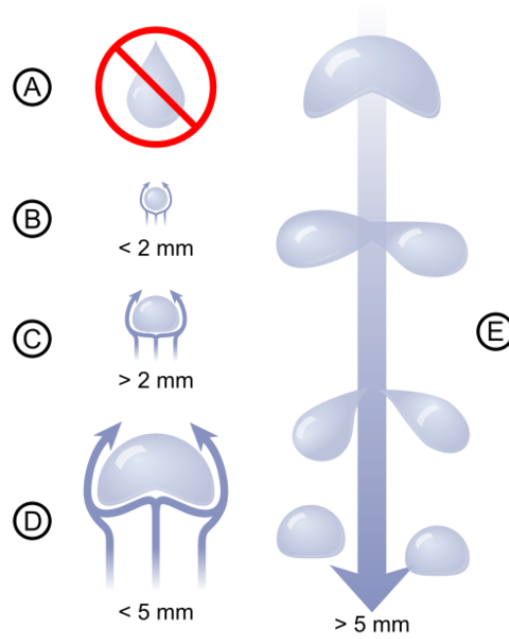
Figure 5: Evolution of the shape of falling water droplets depending on their diameter. Droplets with a diameter below 2 mm are quasi-spherical while droplets above 5 mm diameter tend to divide due to drag force exerted by air. Image from [24]

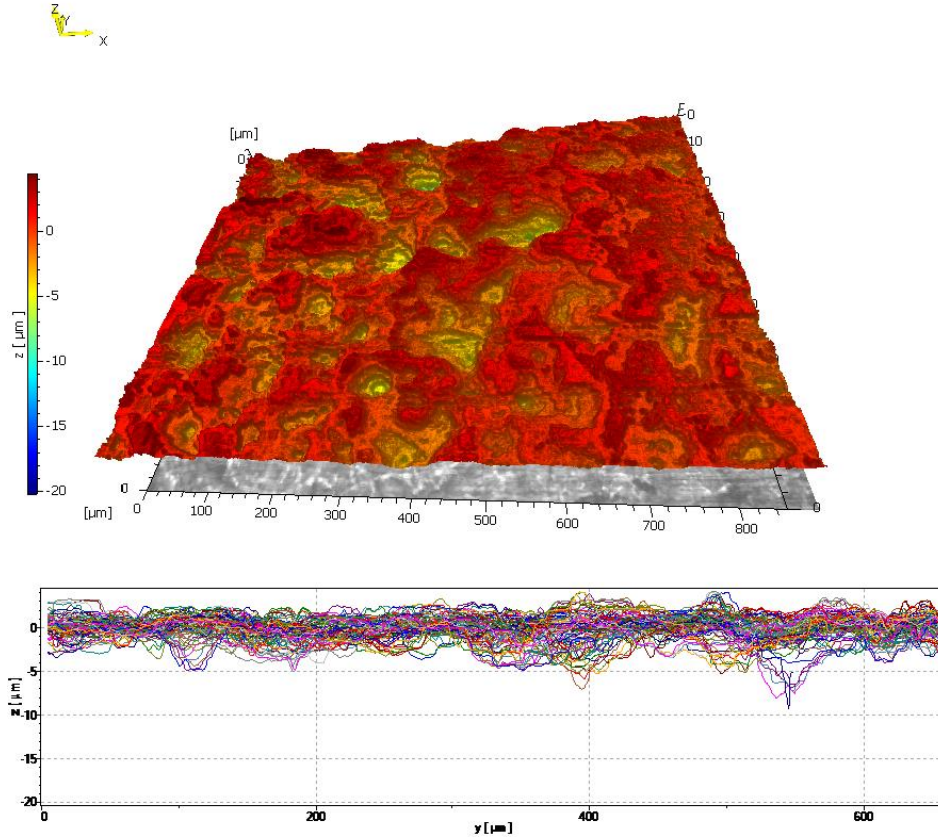
Figure 17: 3D surface profile of zone V of the calibration sample obtained with laser interferometry. The average R_a and R_z values measured over the entire surface are 0.89 μm and 3.66 μm respectively.

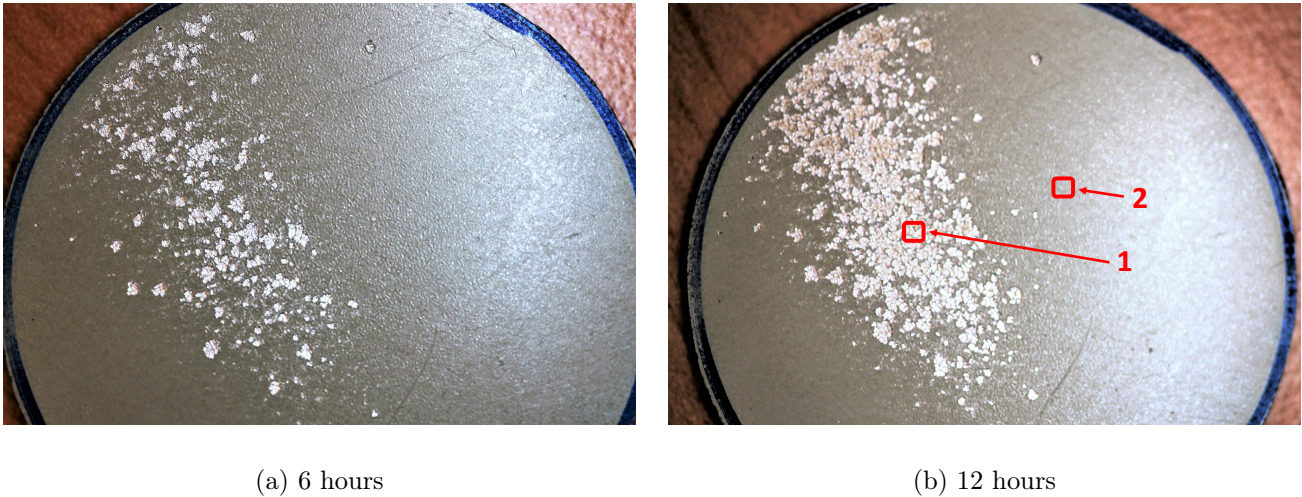
Figure 18: Macro images of the chromium anodized Al2024 with an epoxy coating sample, exposed for (a) 6 hours and (b) 12 hours to erosion at standard conditions in the WAREER.

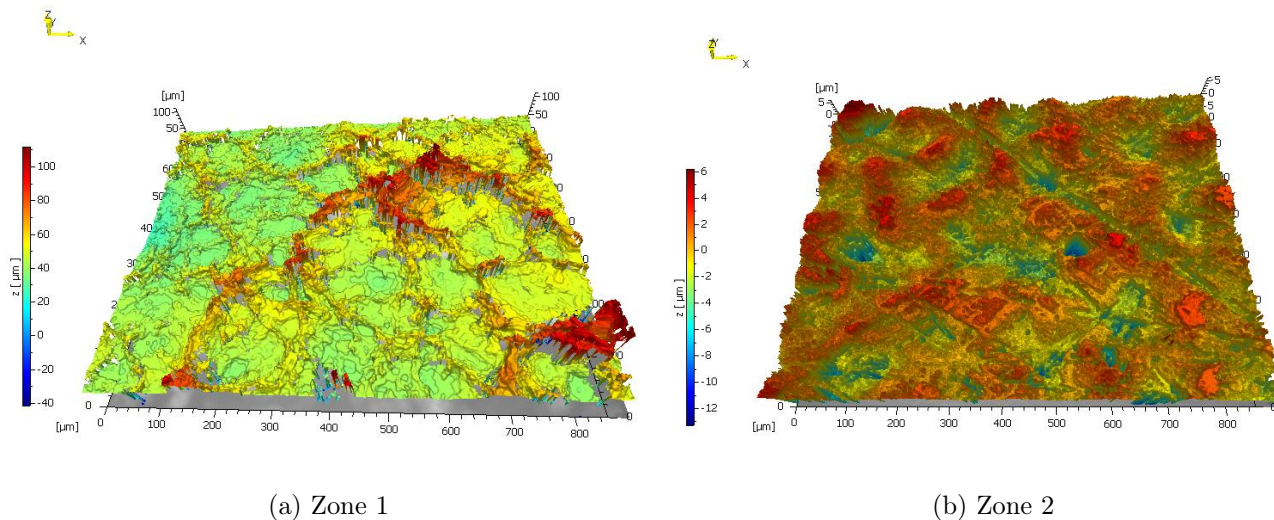
Figure 19: Laser interferometry profiles captured for (a) zone 1 and (b) zone 2 of the chromium anodized Al2024 sample with epoxy coating.

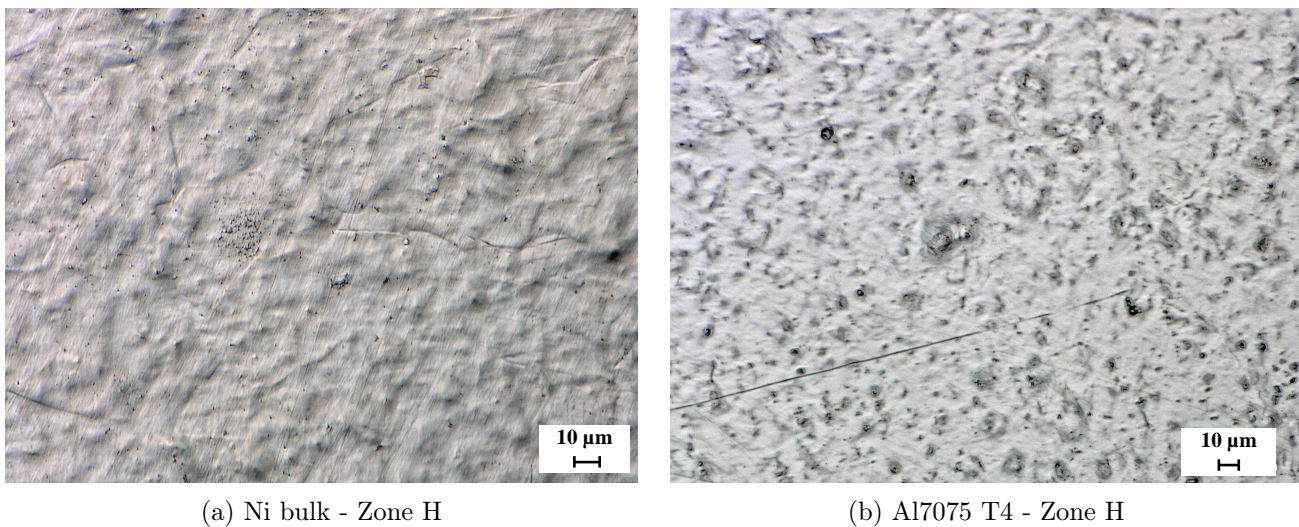
Figure 29: Digital microscopy images showing the smooth depressions on two PJET samples, namely (a) Ni bulk and (b) Al7075 T4.

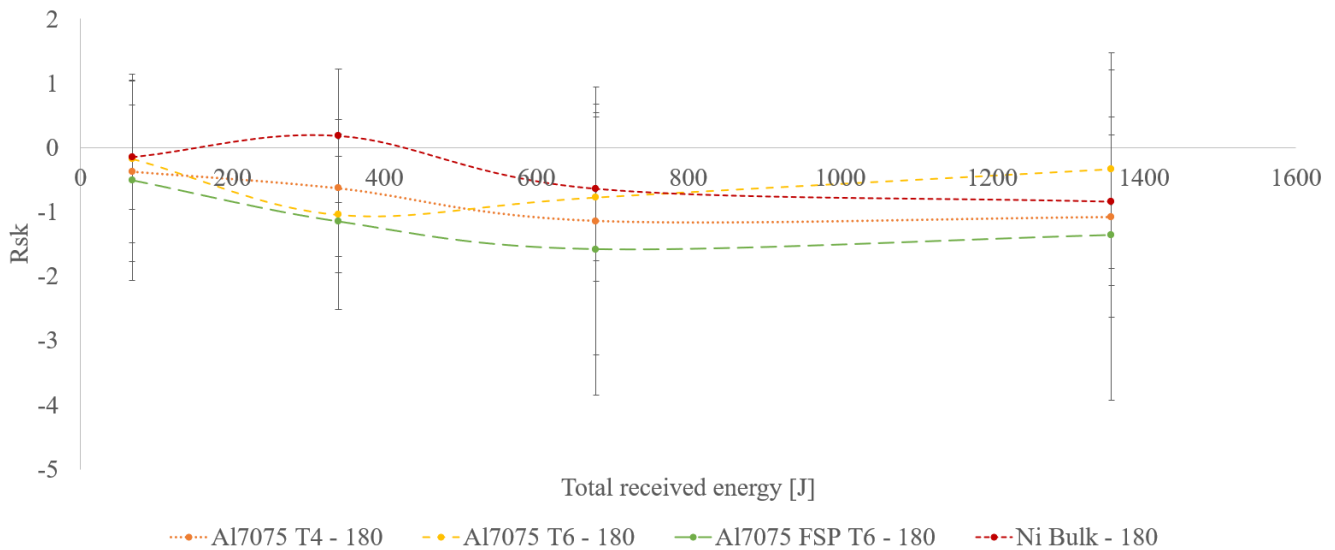
Figure 51: Evolution of the R_{sk} of the Al7075 T4, Al7075 T6, Al7075 FSP T6 and Ni bulk samples as a function of the energy received, for impact speeds of 180 m/s in the PJET.
